# **Rail Shipments Of Diluted Tar Sands:**

# **THE AFTERMATH**

# PHOTOS | Oil pooling at creek near Gogama train derailment: Environment Ministry

## Why bitumen isn't necessarily safer than Bakken

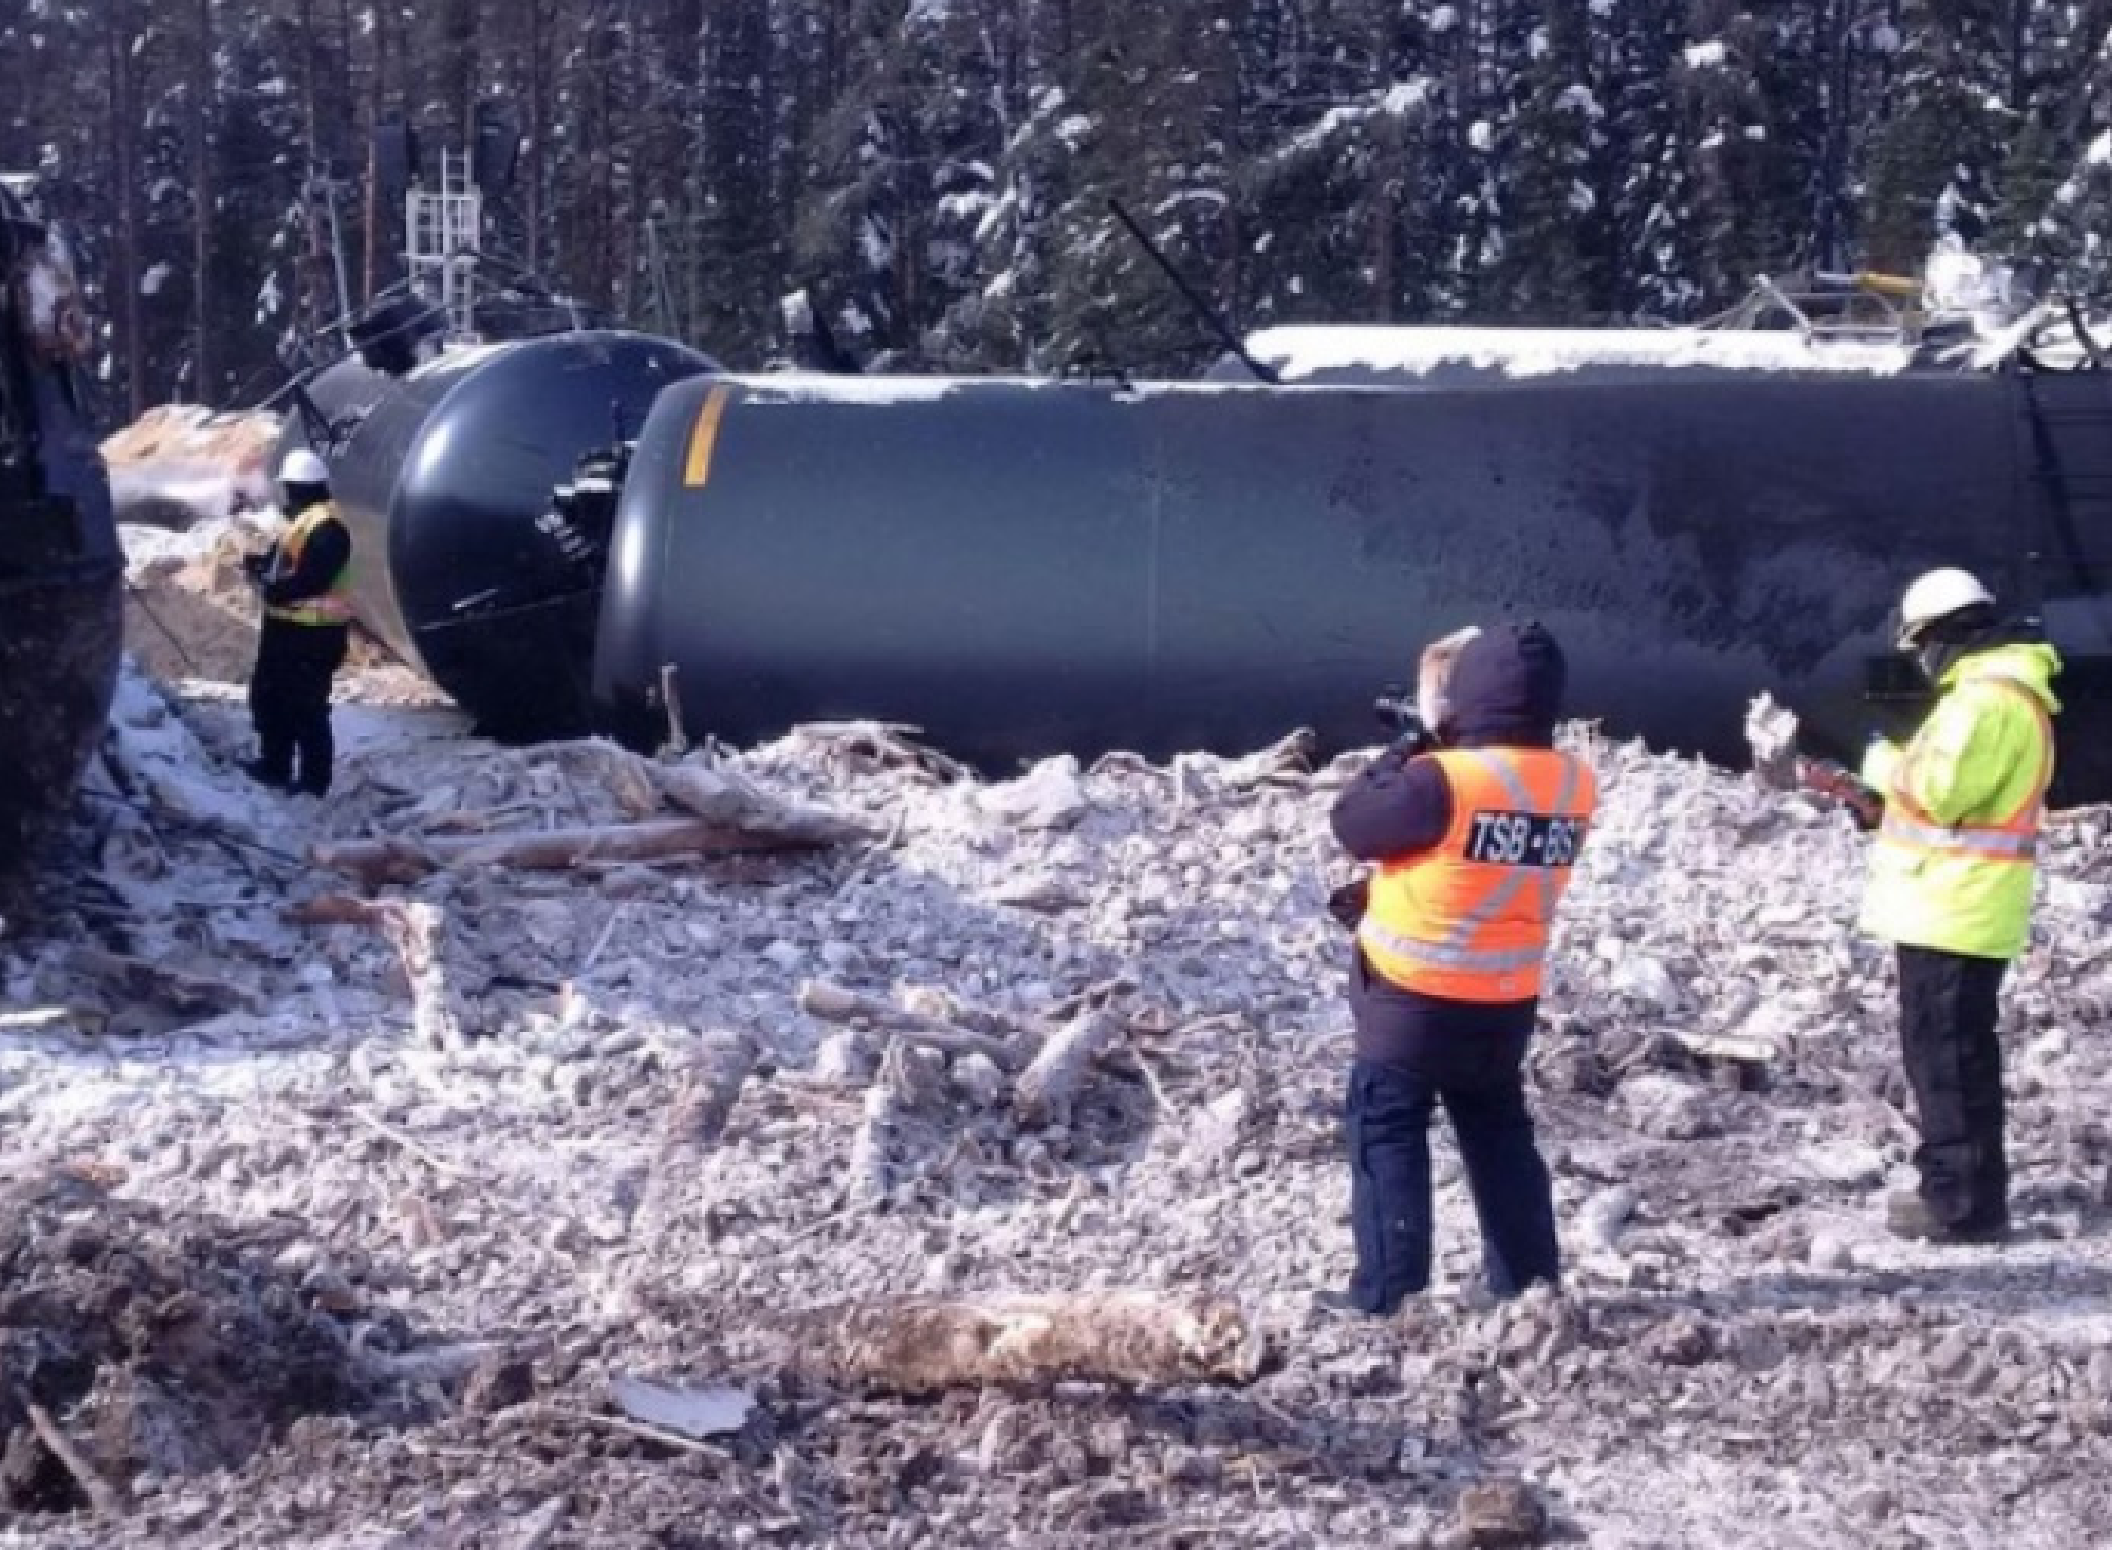
Transportation Safety Board investigators Document and assess the accident site near Goddard, Ont. (TSB)

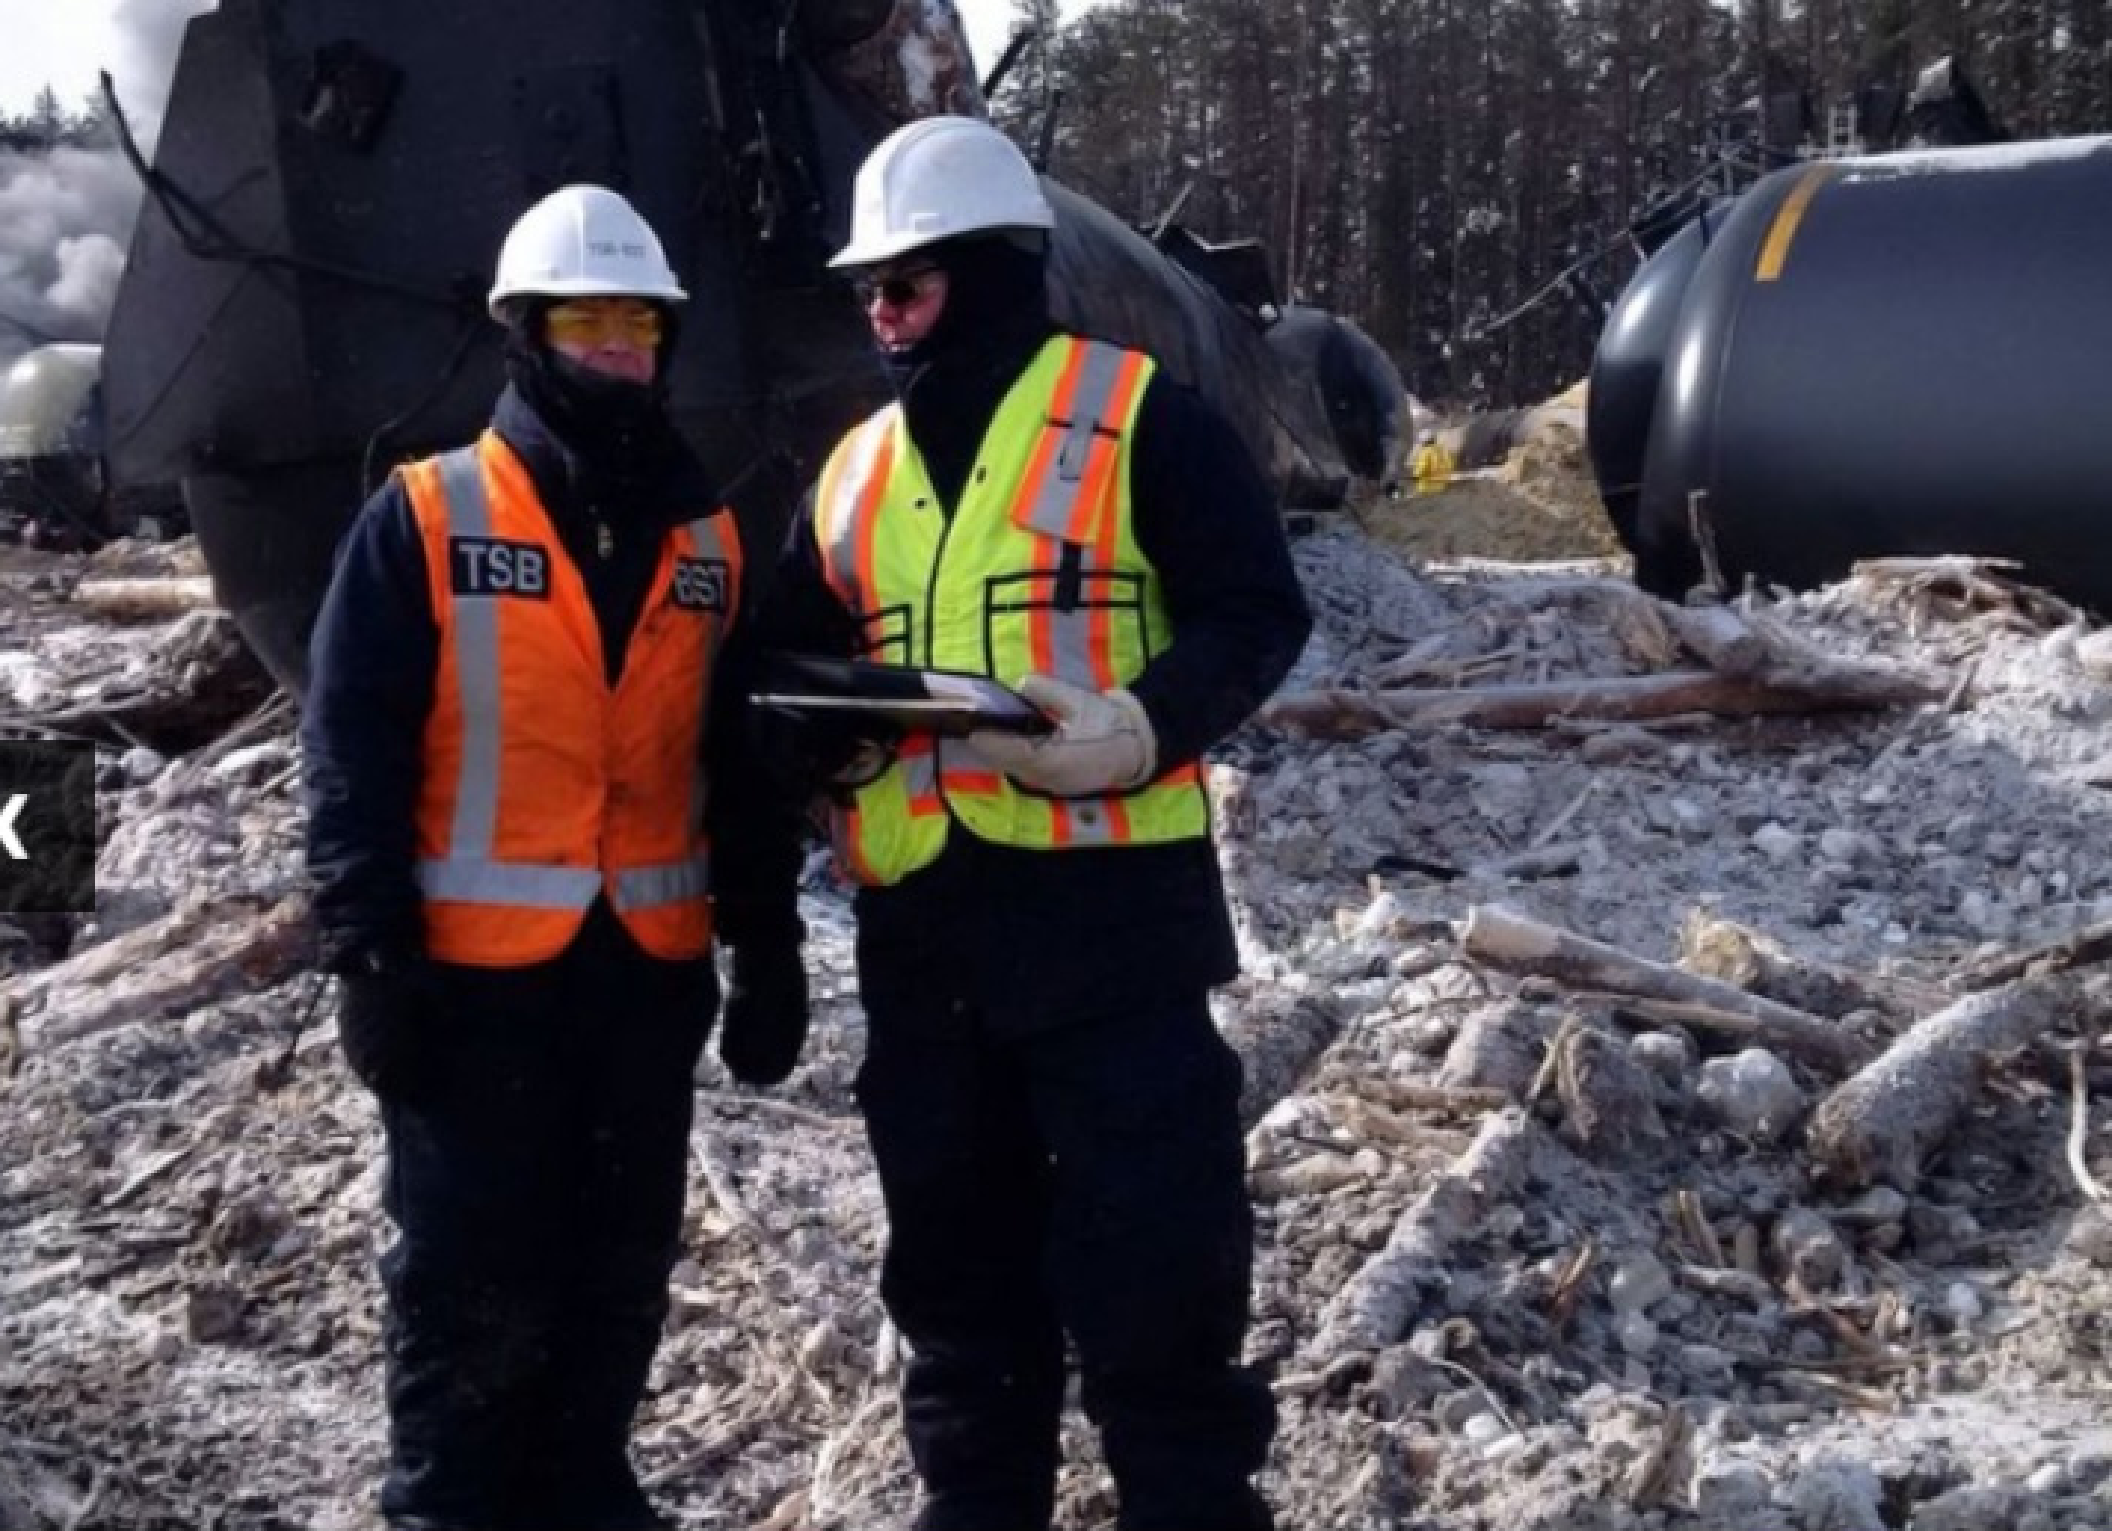
Two TSB investigators on site at the train derailment near Gogama, Ont. (TSB)

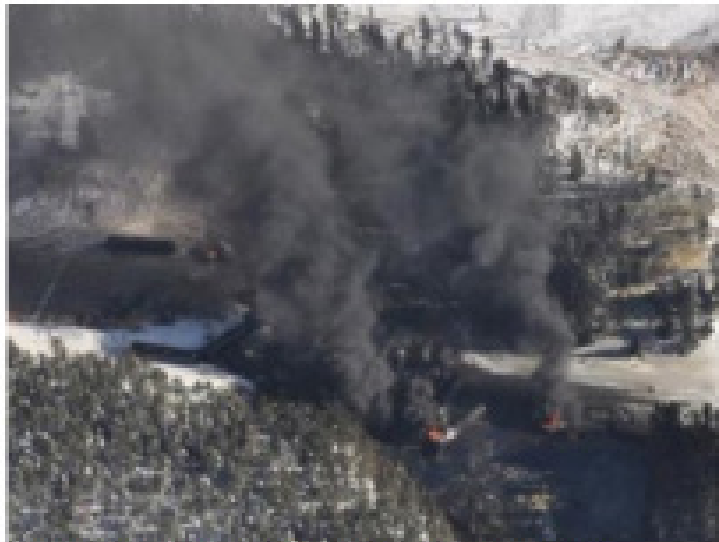
Feb. 14, 2015 CN oil train derailment near Gogama, Ontario

The chain reaction fireballs that attended the Feb. 16, 2015 derailment of a CSX unit oil train in populated West Virginia probably blinded observers to the significance of the concurrent derailment and explosions of a CN oil train in a remote and uninhabited area of northern Ontario. Most reports treated the two events as equals, given that both trains consisted of recently manufactured CPC-1232 tank cars loaded with crude oil.
